NAVWEPS REPORT 7763
NOTS TP 2739
COPY 87

EVALUATION OF THE EXPERIMENTAL MODEL OF THE RADAR SET GROUP OA-2003(XN-1)/ASB

F. L. Guthleben
Sara G. Valdivia
Aviation Ordnance Department

October 1962

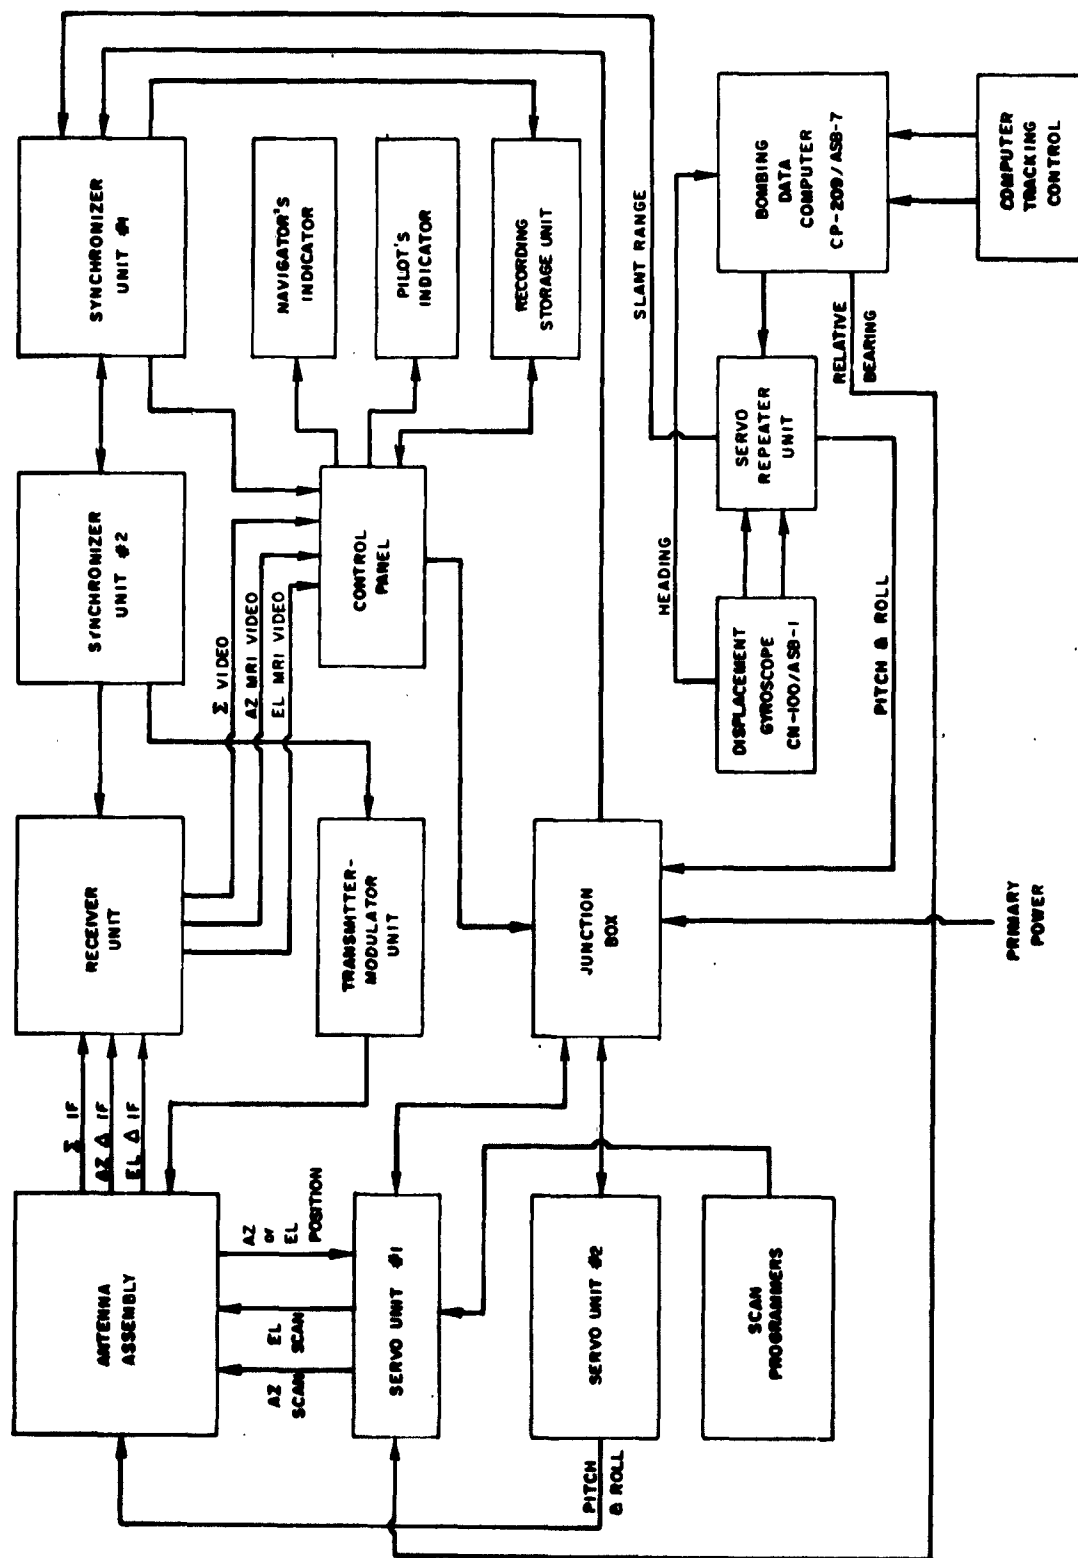
FIG. 4. Radar Set Group OA-2003/ASB Block Diagram

The Radar Set Group OA-2003/ASB (Fig. 1, 2, 3, and 4) is a four-horn monopulse K_u -band radar, tunable over the range of 16 to 17 gigacycles (gc), with a rated peak power output of 60 kilowatts (kw). The four-gimballed antenna is stabilized in roll and pitch to the vertical; in azimuth to the aircraft datum line (ADL), the aircraft drift angle, or the horizontal line of sight (LOS); and in elevation to the angle of attack, the horizontal, or the elevation LOS. The radiated beam is either pencil or fan shaped (cosecant-squared) in the vertical plane, and pencil shaped in the horizontal plane.

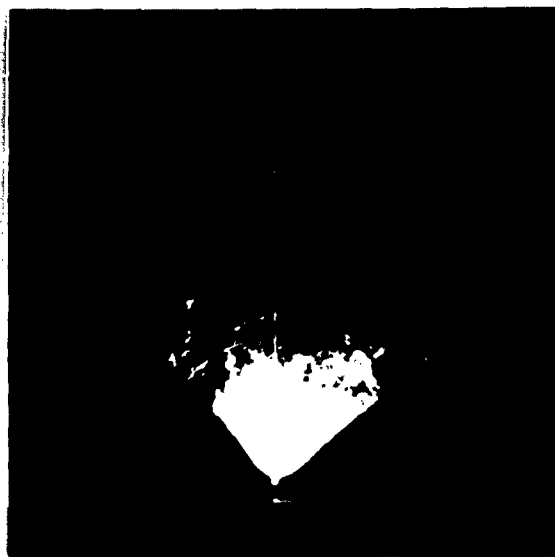
(a) Fan beam.

(b) Pencil beam.

FIG. 5. 120-Mile Displays Showing Difference in Antenna Gain. San Luis Obispo area, heading 90 degrees; 20-mile markers, wide pulse.

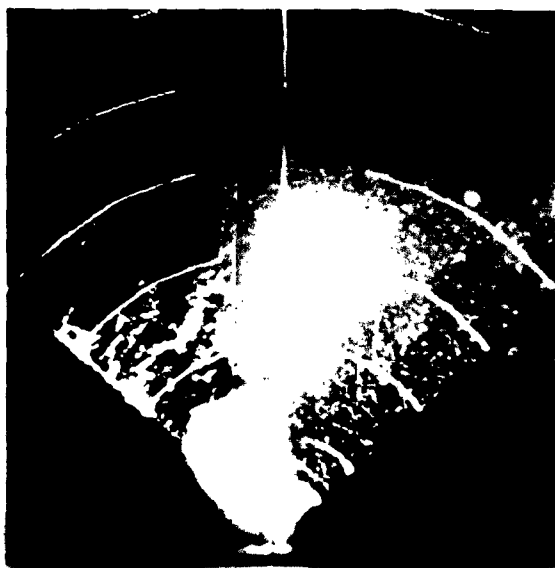
(a) Fan beam.

(b) Pencil beam.

FIG. 6. Displays Showing Difference in Antenna Gain Between Wide-Pulse Pencil-Beam and Fan-Beam Operation. Los Angeles area, looking south toward coastline, heading 225 degrees; 20-mile markers.

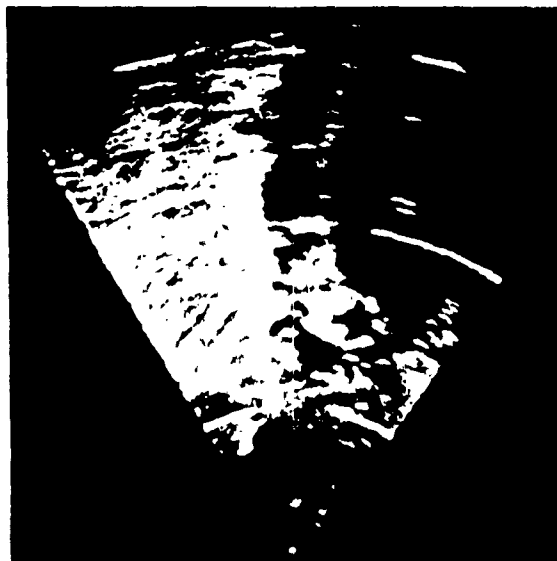
(a) San Diego—North Island area.

(b) Los Angeles area, showing street pattern.

FIG. 19. Displays Showing Improvement of Distortion. Narrow pulse; pencil beam.

The presentation displayed on the navigator's indicator, conventional cathode-ray tube (CRT), showed a combination of video distortion, 400-cycle noise, inadequate contrast, and initially insufficient gain to permit the display of receiver noise (Fig. 7, 8, 17, 18, and 31). Figure 9 illustrates the undesirable characteristics of noise in the display when sufficient gain was provided and the variation in the noise level with the change in pulse repetition frequency (PRF). The video distortion and the noise problems were largely associated with poor grounds and inadequate shielding of the wiring within the indicator. The noise problem was never completely eliminated, but was improved in time. The inadequate contrast and receiver noise problems were found to have been caused by the video processing circuit where the video, markers, and the unblanking pedestal were mixed, and were attributed to poor direct-current (d.c.) restoration. In time, the contractor provided a newly designed circuit that greatly improved the problem (Fig. 10, 11, 12, 15, 16, 19, and 20).

Flt. No.	Date	Comments
15	2 May 60	<p>Rerouting, careful grounding, and additional shielding of leads in the navigator's indicator eliminated much of the noise pickup. The aircraft was grounded until 2 May for engine maintenance.</p> <p>This local flight was canceled 25 minutes after takeoff because of engine trouble. The track-while-scan looked good during a short check except for some mechanical overshoot of the antenna during the initial lock-on. Operation of the spoiler seemed sluggish.</p> <p>Maintenance. The spoiler problem was caused by a faulty capacitor in the phase-shifting winding of the spoiler drive motor. A new NAFI-developed MRI circuit was installed.</p> <p>SFO. On this 4-1/2-hour flight to the Bay area, a few terrain-clearance pictures were taken while crossing the Sierra Range, and the MRI looked good in this mode but was unstable. Several pictures of the radar presentations were taken over the Bay area, but the radar was not working well in the Mapping mode. The receiver sensitivity was down and there was considerable waviness on the expanded presentations.</p> <p>Maintenance. Previous trouble with the vacuum switch was remedied by substituting a new coil with increased ampere-turns. The MRI circuit was reworked to give better frequency response. The indicator was again reworked to remove noise pickup.</p> <p>This was an inertial navigation flight of 4-1/2 hours to Gila Bend, Arizona, and return.</p> <p>LAX, SAN. The radar presentation of the Los Angeles area looked very good; this was the first flight on which city streets were discernible in a city complex (Fig. 19).</p>

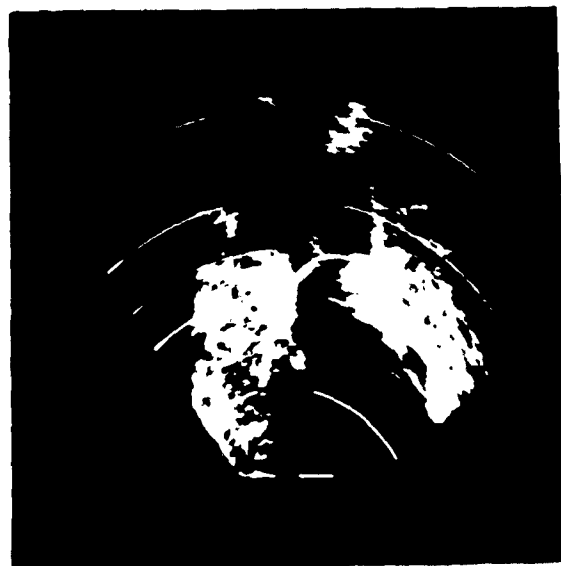
(a) 21-mile range.

(b) 15-mile range.

(c) 14-mile range.

(d) 12-mile range.

FIG. 20. Bombing—Navigation Mode, Unexpanded Display; San Francisco Bay Bridge and Treasure Island. Narrow pulse; fan beam; ranges are from aircraft to Treasure Island.

(e) 10-mile range.

(f) 8-mile range.

(g) 6-mile range.

(h) 5-mile range.

FIG. 20 (Contd). Bombing—Navigation Mode, Unexpanded Display; San Francisco Bay Bridge and Treasure Island. Narrow pulse; fan beam; ranges are from aircraft to Treasure Island.

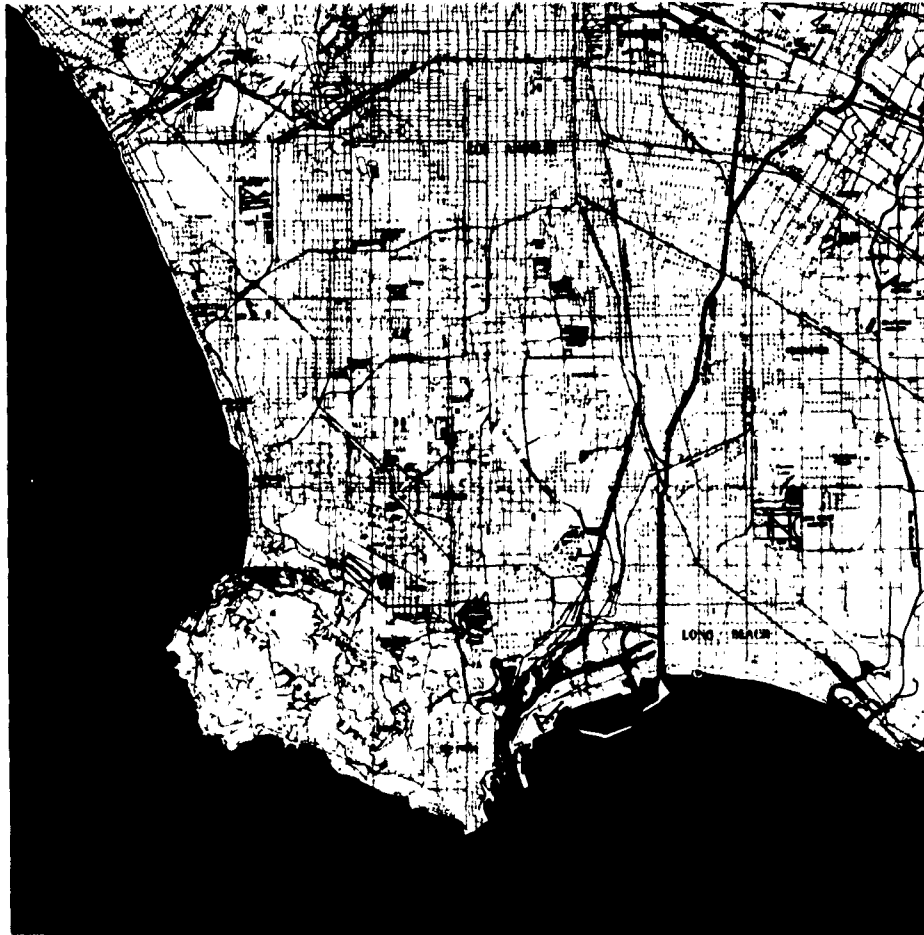
FIG. 21. Radar Target, Los Angeles Area, Including Long Beach.

^aFlight routes (maps and photographs of areas are shown in Fig. 13, 14, 21, and 22)
SFO, San Francisco
LAX, Los Angeles
SAN, San Diego

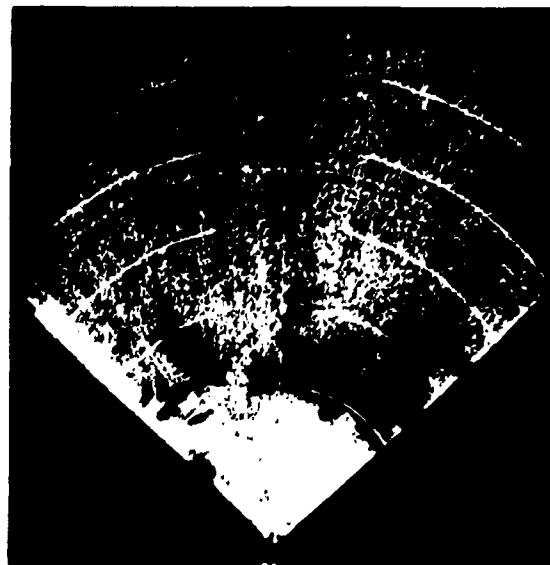
(a) Σ only, maximum gain.

(b) Δ only, maximum gain.

(c) Maximum Σ gain, Δ adjusted for best apparent MRI.

(d) MRI with sacrifice of sensitivity.

FIG. 23. Comparison of Ground-Test Displays Before Changes to MRI Circuitry.

It was evident from the outset that MRI operation in azimuth was totally inadequate. This was considered the major design deficiency of the radar set. The trouble was pinpointed to the sum (Σ) and difference (Δ) video processing circuits. Throughout the flight-test program, considerable effort was expended by both NOTS and contractor personnel in designing suitable circuitry to achieve the desired results. A circuit design that could adequately improve resolution in azimuth could not be made compatible with the receiver as designed. Figures 10, 11, 12, 15, 16, 23, 24, 25, and 26 show various MRI displays.

The MRI circuit originally installed in the radar was purely a summing device without provisions for d.c. restoration or adequate clipping, and it caused (1) variations in the baseline level and (2) large amounts of noise from the Δ channel to appear on the navigator's indicator. Several modifications were made to the circuitry, and ground-test results are presented in Fig. 23, 24, 25, and 26.

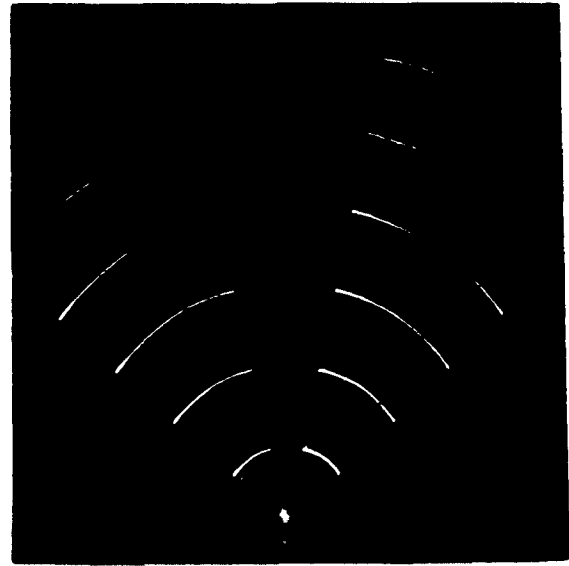
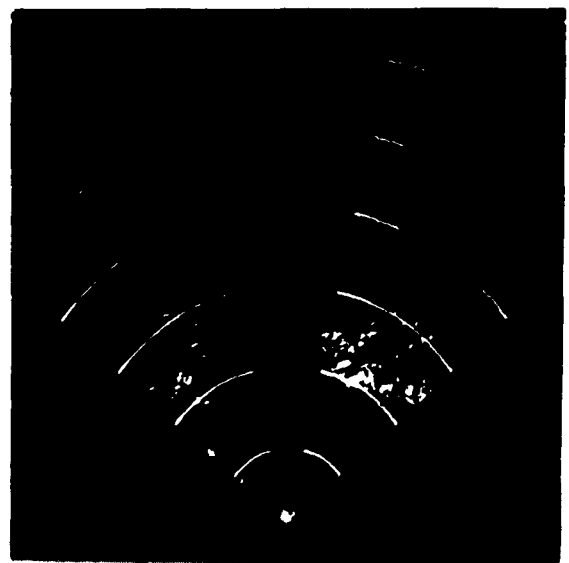
(a) Σ only, maximum gain.

(b) Δ only, maximum gain.

(c) Maximum Σ and maximum Δ .

(d) Maximum Δ , lower Σ gain.

FIG. 24. Comparison of Ground-Test Displays Following Addition of Series Clipper to MRI Circuit. Note elimination of noise in (b) as compared with 23(b); note loss of sensitivity in (c) and (d).

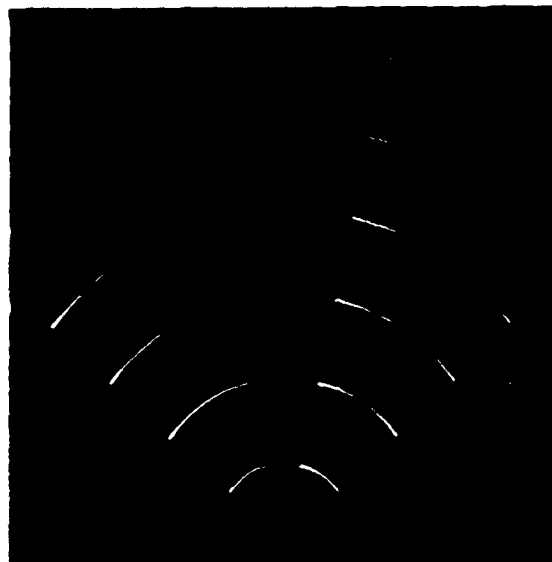
(a) Maximum Σ , no Δ .

(b) Maximum Δ .

(c) Maximum Σ and maximum Δ .

(d) Maximum Δ , Σ gain reduced.

FIG. 25. Comparison of Ground-Test Displays Employing Elevation MRI Circuit in Azimuth With Series Clipper. Note increase in noise in (c) and loss of sensitivity and poor MRI in (d).

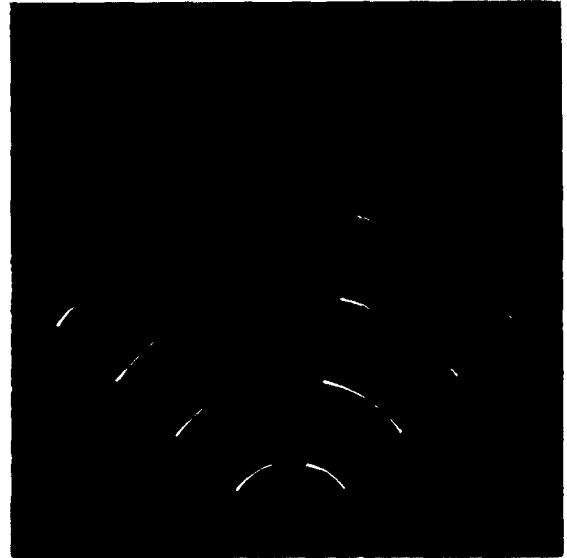
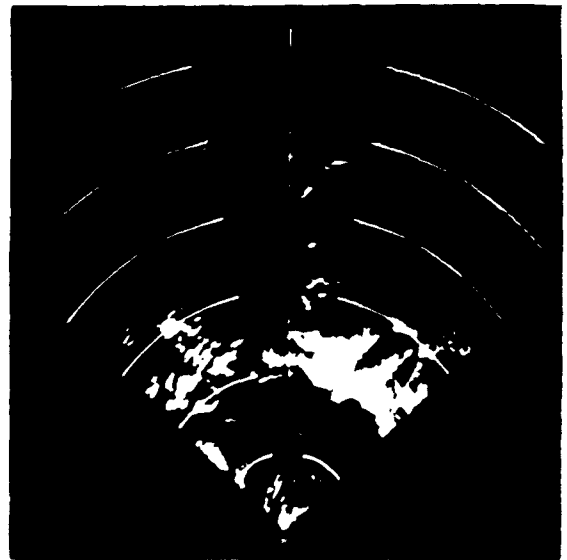
(a) Maximum Σ .

(b) Maximum Δ .

(c) Maximum Σ and maximum Δ .

(d) Maximum Σ and maximum Δ .

FIG. 26. Comparison of Ground-Test Displays Employing MRI Replacement Circuit of Fig. 27. Note slight improvement in sensitivity in (d).

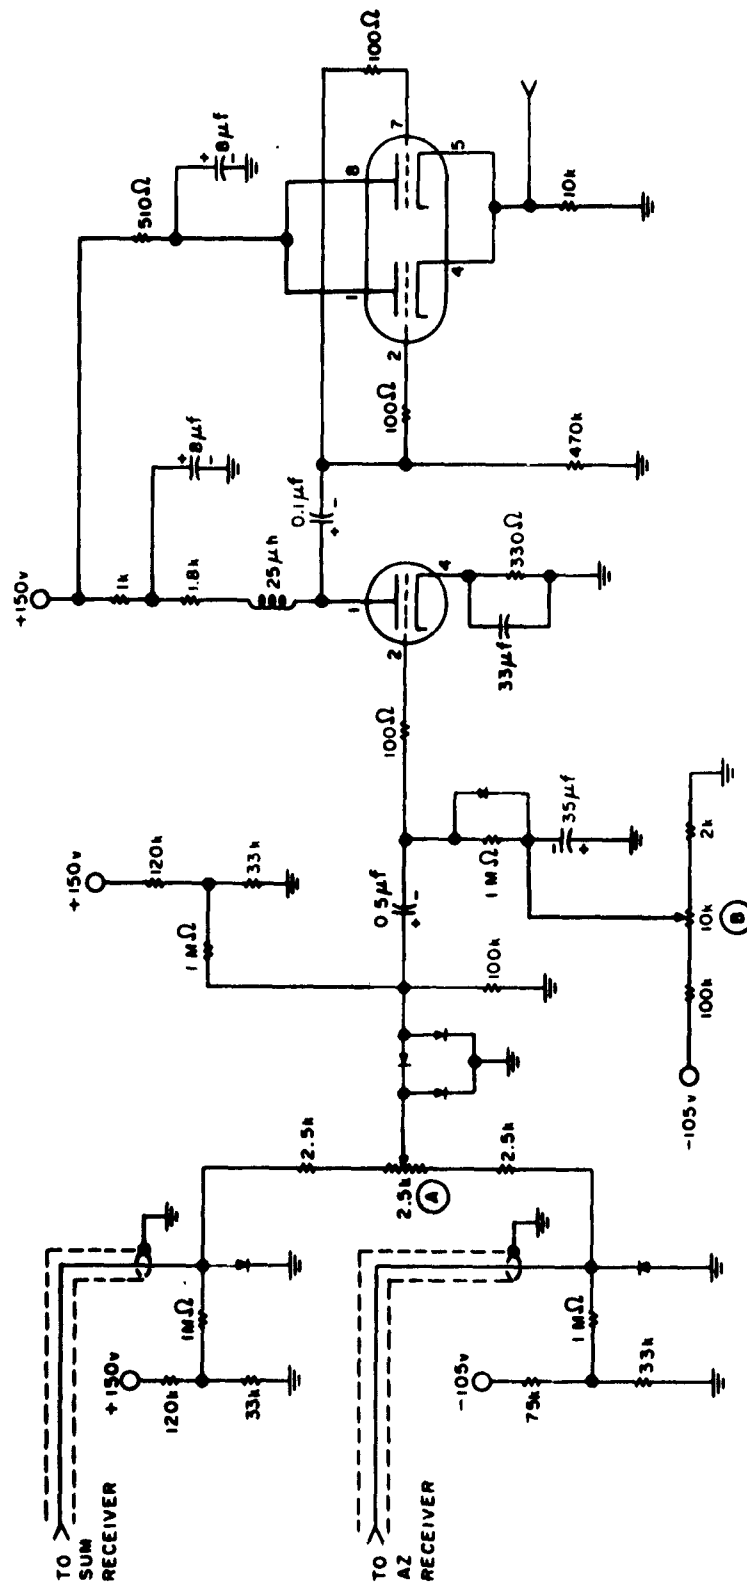
FIG. 27. MRI Replacement Test Circuit.

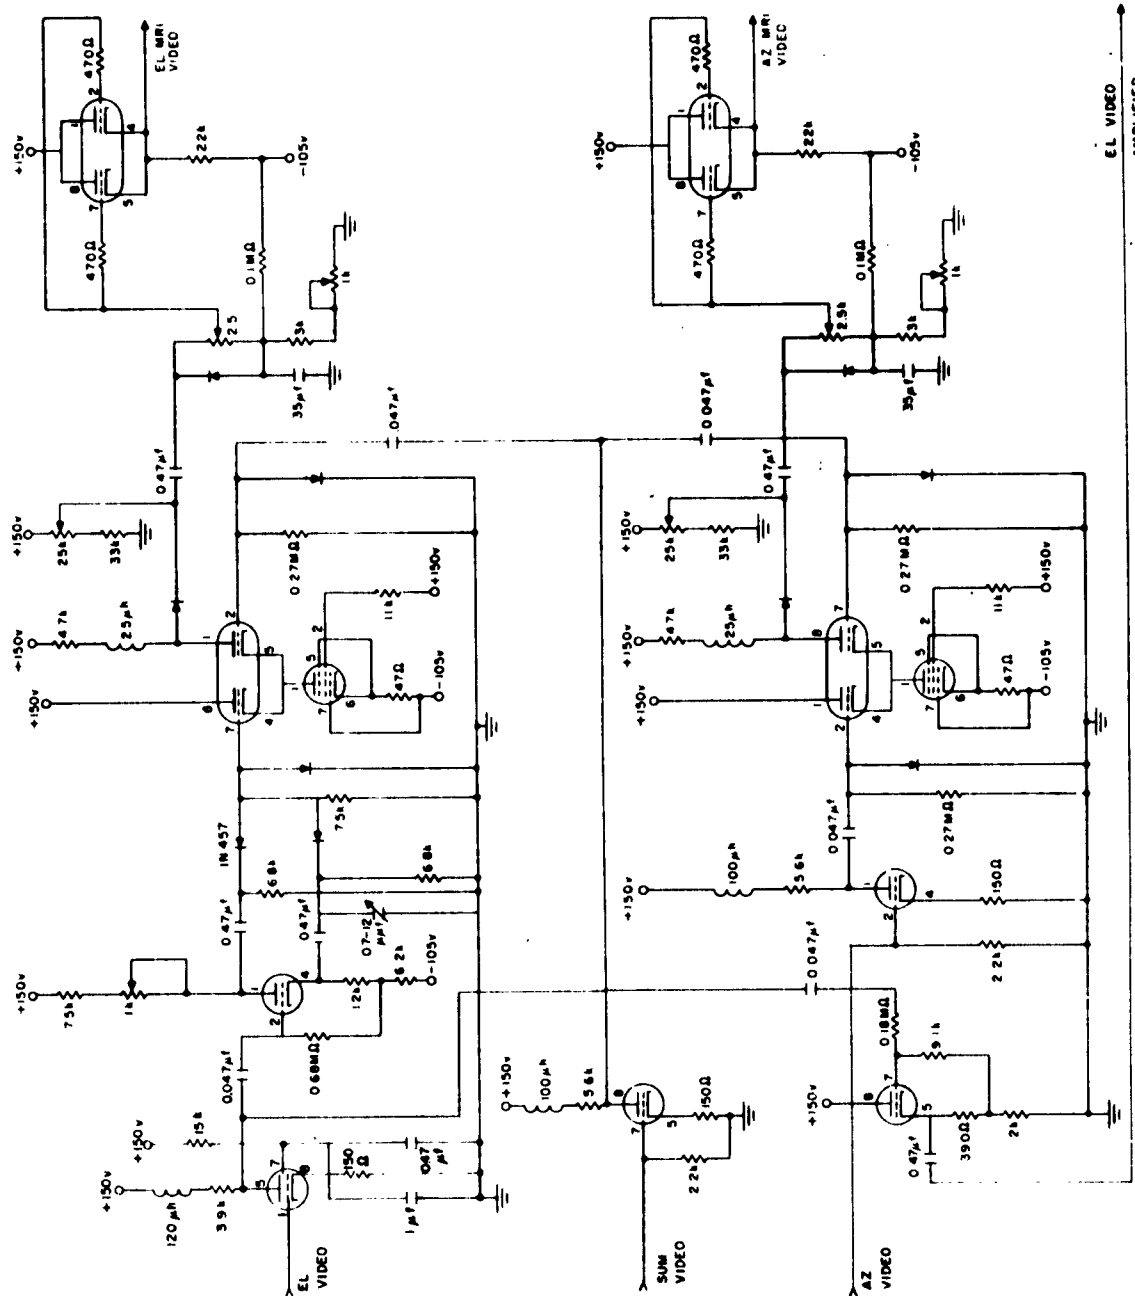
FIG. 28. NAFI-Developed MRI Circuit.

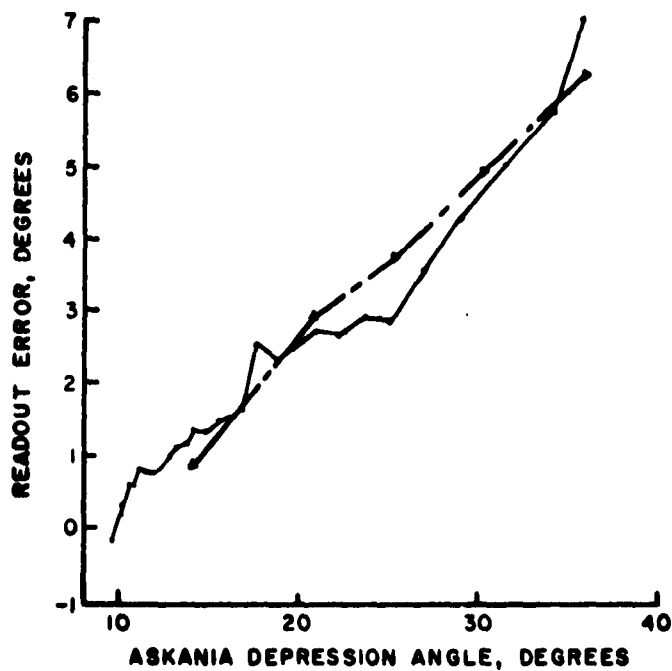
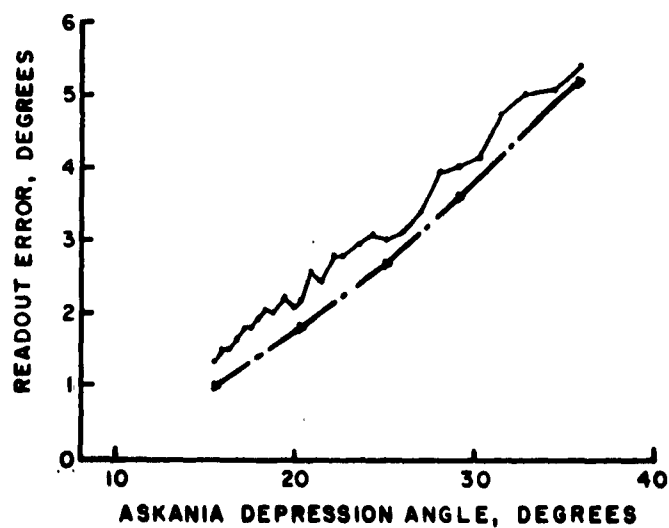
(a) Flight 26, Run 4.

(b) Flight 26, Run 7.

— Actual radar depression-angle error.
- - - Computed curve for target 2,000 feet north.

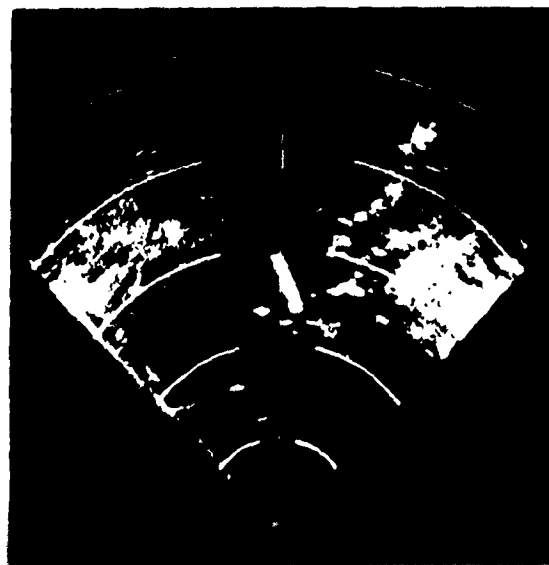
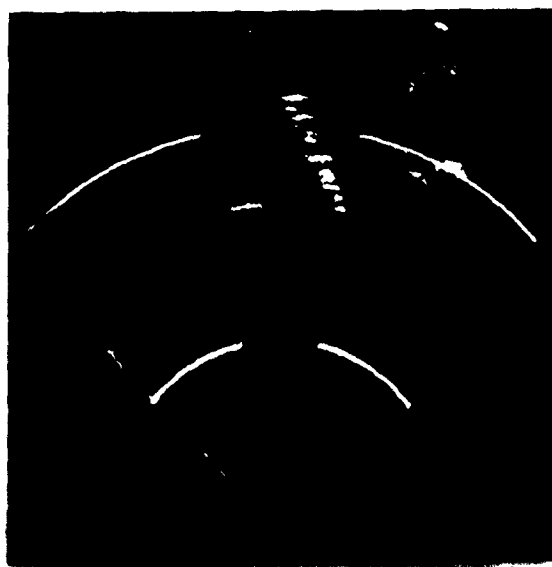
(a) 22-mile range.

(b) 13-mile range.

(c) 9-mile range.

FIG. 30. Displays from 20,000 Feet. Mothball fleet; fan beam; narrow pulse; 5-mile markers.

A total of 28 flights was made. The target areas included San Diego, Los Angeles, San Francisco, and Death Valley. All flights were at 10,000 feet mean sea level (m.s.l.) with the exception of flights 11 and 12. Figure 30 is indicative of the results of Flight 12 at 20,000 feet.

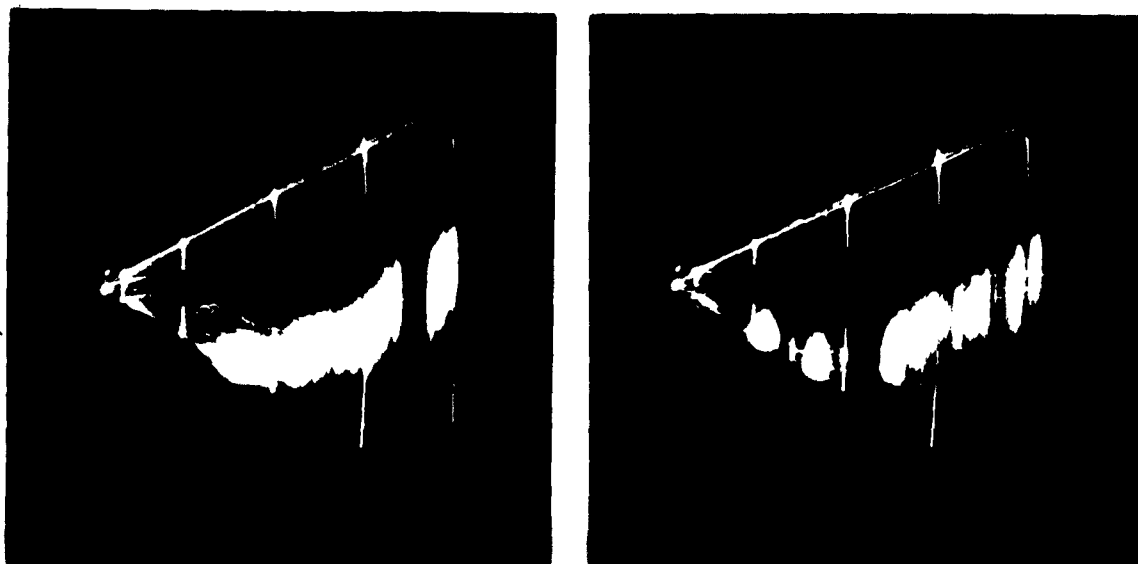
FIG. 31. Terrain Clearance, Range Height Indicator. Five-mile markers; Σ only.

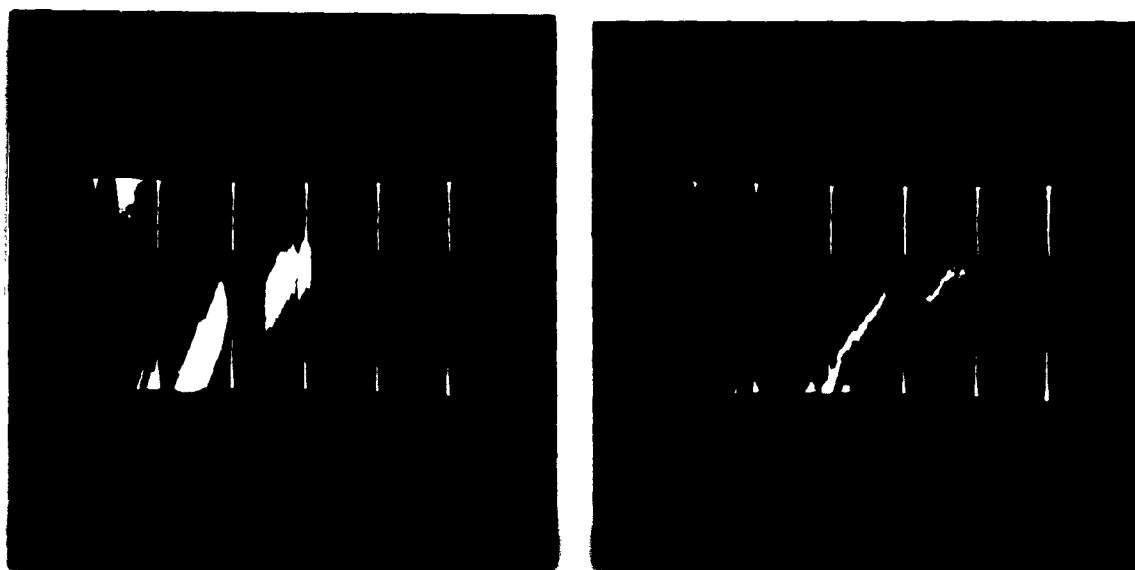
(a) Σ only.

(b) MRI.

FIG. 32. Terrain Clearance, E.Scan. Two-mile markers.

Two types of false targets appeared when the elevation MRI circuitry was used in the Terrain Clearance mode. These are termed "shadows" and "wings", and examples are shown in Fig. 32b, 33 and 34. Double targets were caused by negative overshoots in the elevation video circuits, and wings were caused by interaction between the sum and elevation difference channels. Figures 35 and 36 show the results when these effects were minimized.

Flt. No.	Date	Comments
		sensitivity and an increase in noise on the indicator in the form of streaks or flashes.
		Maintenance. The cause of the loss of sensitivity could not be determined, since everything appeared to be working normally during ground checks. The indicator noise appeared when the depression axis of the antenna was moved.
13	24 Mar 60	This flight was to check performance in the <u>Terrain Clearance</u> mode (Fig. 31 and 32). Six runs were made on <u>Telescope Peak</u> (11,049 feet) in the <u>Death Valley</u> area with the aircraft flying at 10,000 feet m.s.l. Two types of false targets appeared when using MRI in the <u>Terrain Clearance</u> mode. These are termed "shadows" (double targets) and "wings," examples of which are shown in Fig. 32b, 33, and 34 (discussion on page 25).

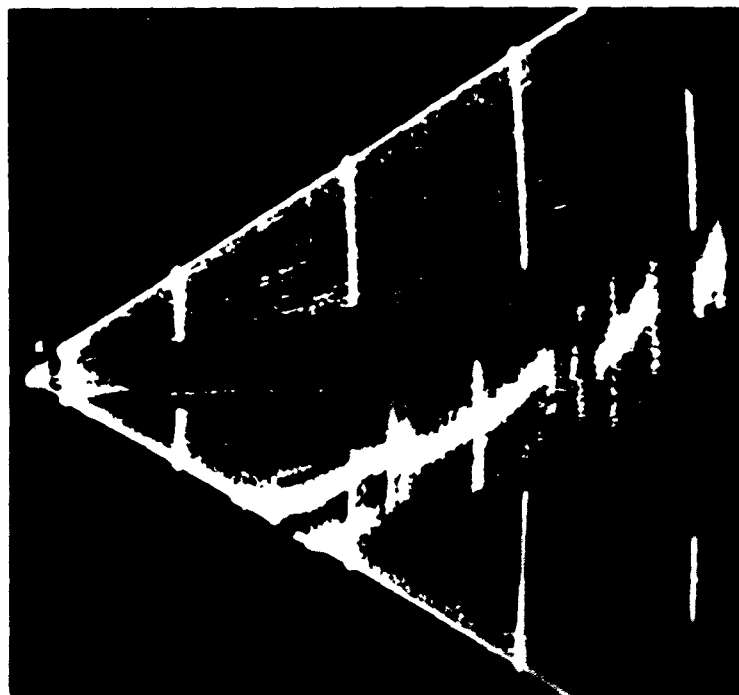
FIG. 34. False Targets, "Wings".

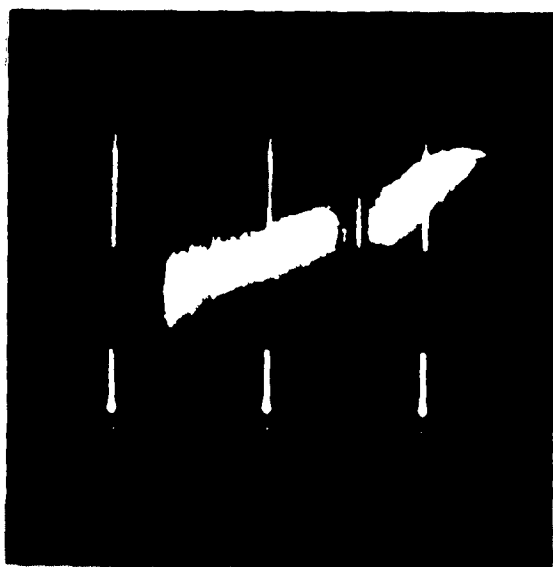
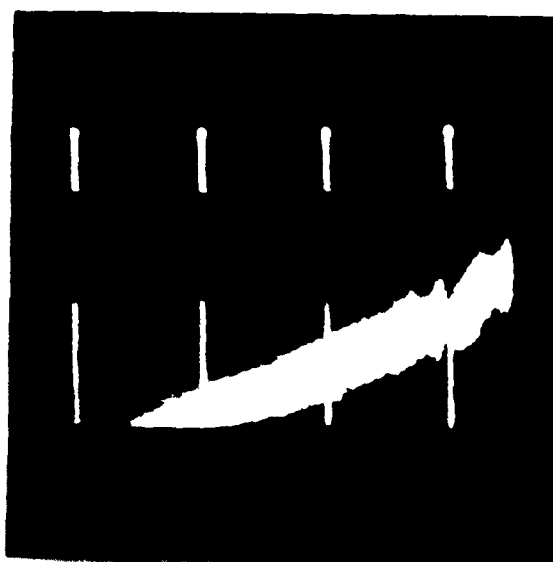
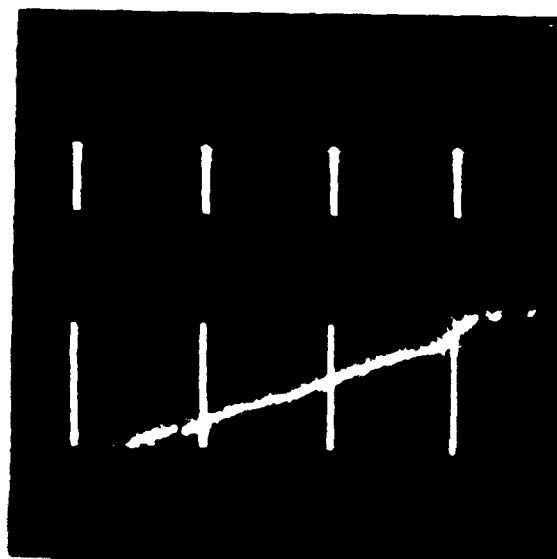
(a) Σ only.

(b) MRI.

(c) Σ only.

(d) MRI.

FIG. 35. Terrain Clearance, E-Scan; Death Valley Area. Five-mile markers; note improvement in false target problem.

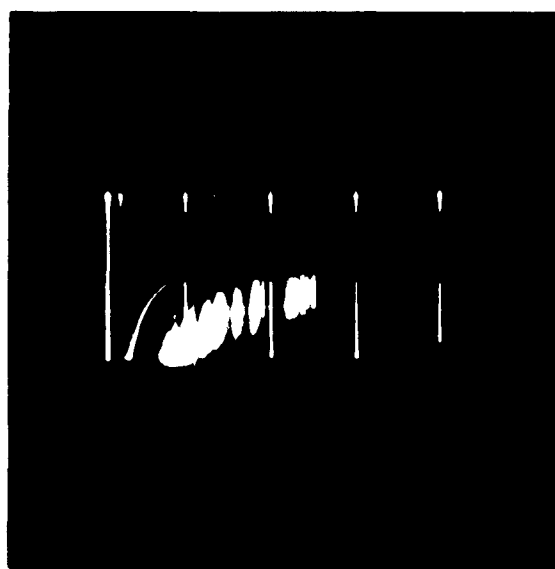
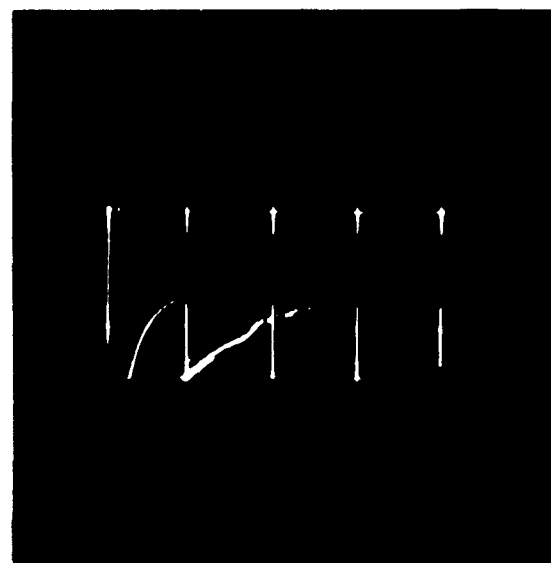
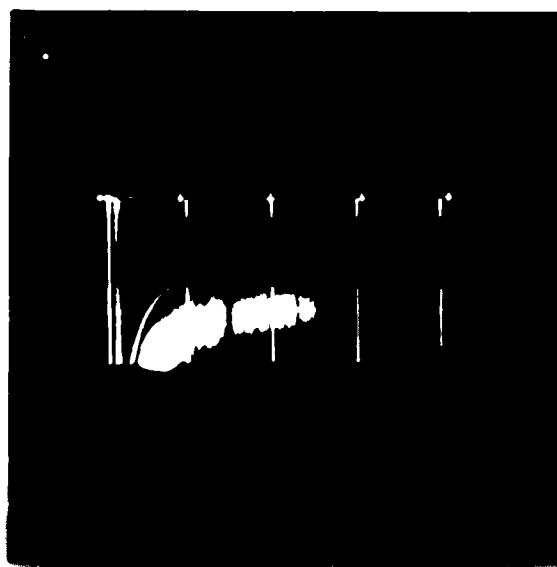
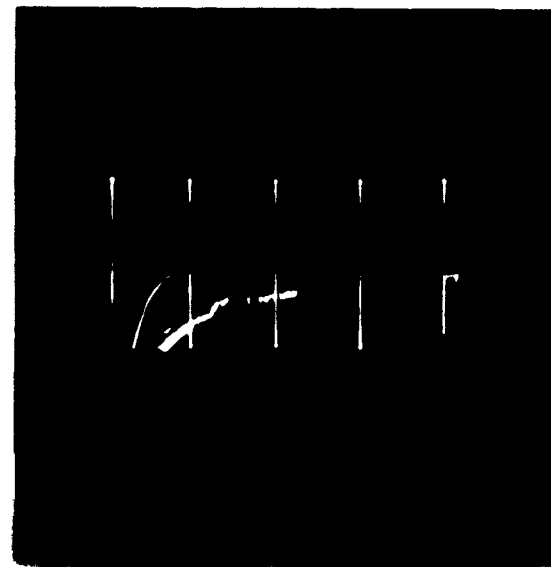
(a) Σ only.

(b) MRI.

(c) Σ only.

(d) MRI.

FIG. 36. Terrain Clearance, E-Scan, Mono Lake Area. Five-mile markers.

-	27 May 60	<p>The scheduled flight was canceled because of a loose propeller blade on the aircraft. Continuous trouble with the aircraft kept it grounded until the flight of 6 July 1960.</p>
20	6 Jul 60	<p>Maintenance. During a ground check of the radar, the 1,000-foot clearance line disappeared. The trouble was traced to an intermittent pulse transformer. The Σ channel 1N78A crystal mixers were replaced with a pair of 1N78Bs to improve sensitivity.</p> <p>SFO. Good radar performance was found to be a function of the adjustment of the clipping level of the MRI unit. The clipping level was extremely difficult to adjust, and drift made it impossible to hold the correct level for a reasonable period. Solid painting to 100 n. mi. and hard targets to 120 n. mi. were observed while the clipping level was in correct adjustment. The MRI looked improved in both the <u>Terrain Clearance</u> (Fig. 36) and <u>Mapping</u> modes.</p>

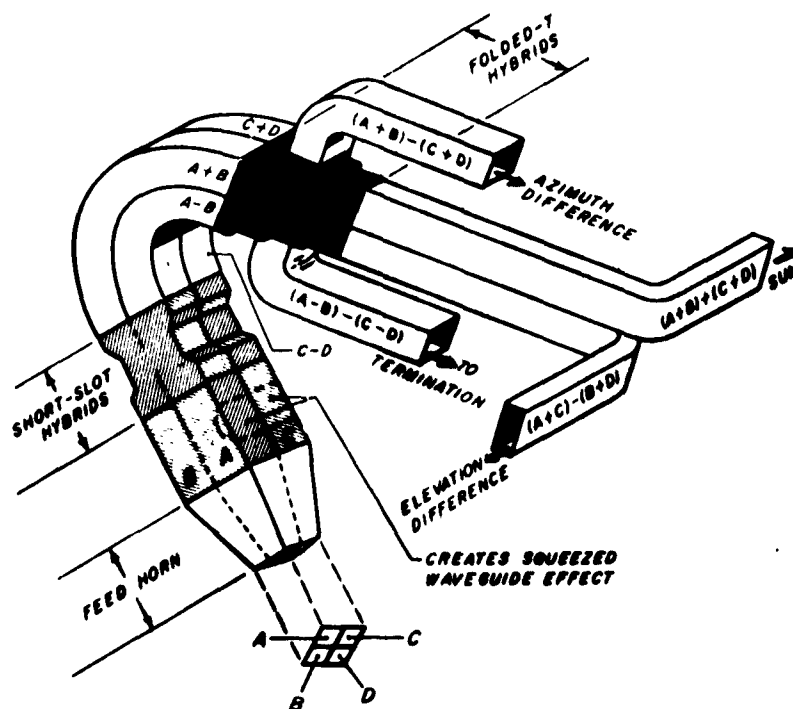
FIG. 40. Comparator and Four-Horn Feed Assembly.

ANTENNA SECTION. To restrict losses in signal strength caused by waveguide attenuation and multiple rotary joints, all microwave components were physically mounted to the rear of the reflector on the elevation axis of the antenna (see Fig. 1). This assembly consists of the transmit—receive (T-R) duplexer, the directional coupler, the klystron local oscillator, the balanced crystal mixers, and four identical pre-IF amplifiers having a 20-db gain.

Through the waveguide transmission lines, these three signals are sent to the waveguide assembly. A part of this assembly consists of the four balanced crystal mixers, where three of the modified signals are independently heterodyned with the local oscillator frequency to produce three IF signals. The mixer crystals are protected during the time the transmitter is pulsed by T-R tube assemblies on the waveguide transmission lines. The fourth mixer receives a sample of the magnetron power, extracted for the AFC circuit by the directional coupler, which is used to maintain the constant 60-Mc difference in frequency between the output of the magnetron and that of the local oscillator.
